TEST REPORT

IP66 and IPX7 test of Tracy and Gracy LED panel

LED iBond A/S Report no.: 122-28175-1 Page 1 of 36 1 appendix

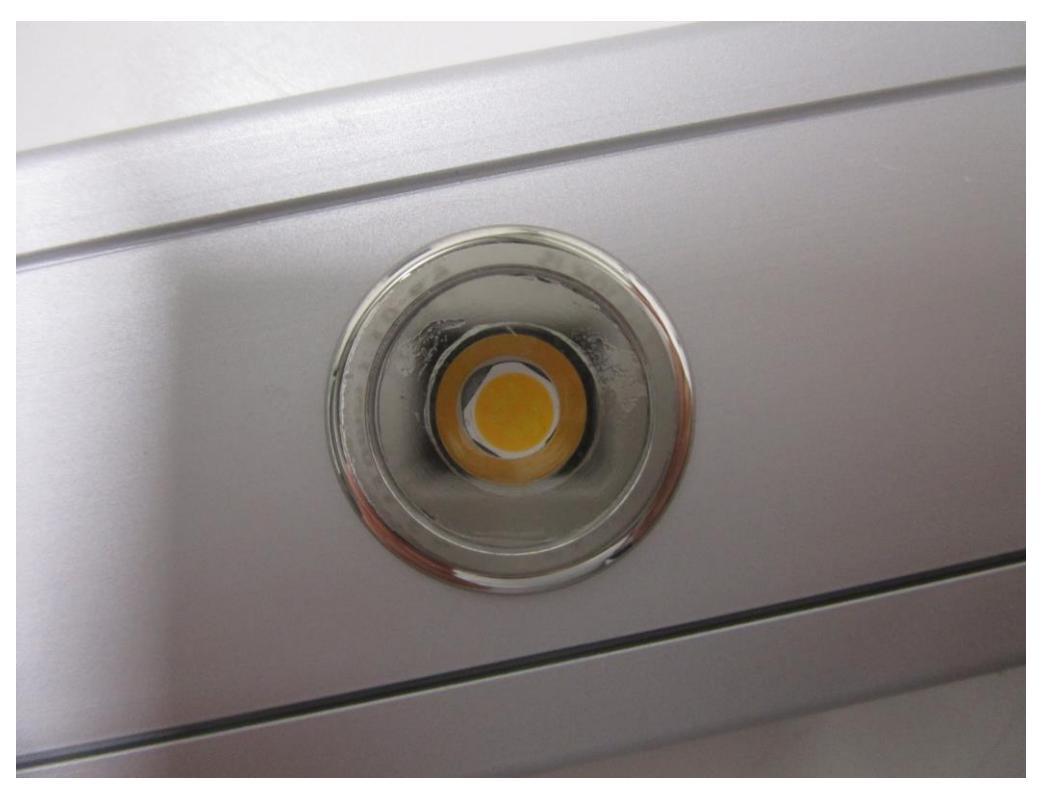
Photo 5 Visual inspection. IP6X. No dust observed inside LED sockets.

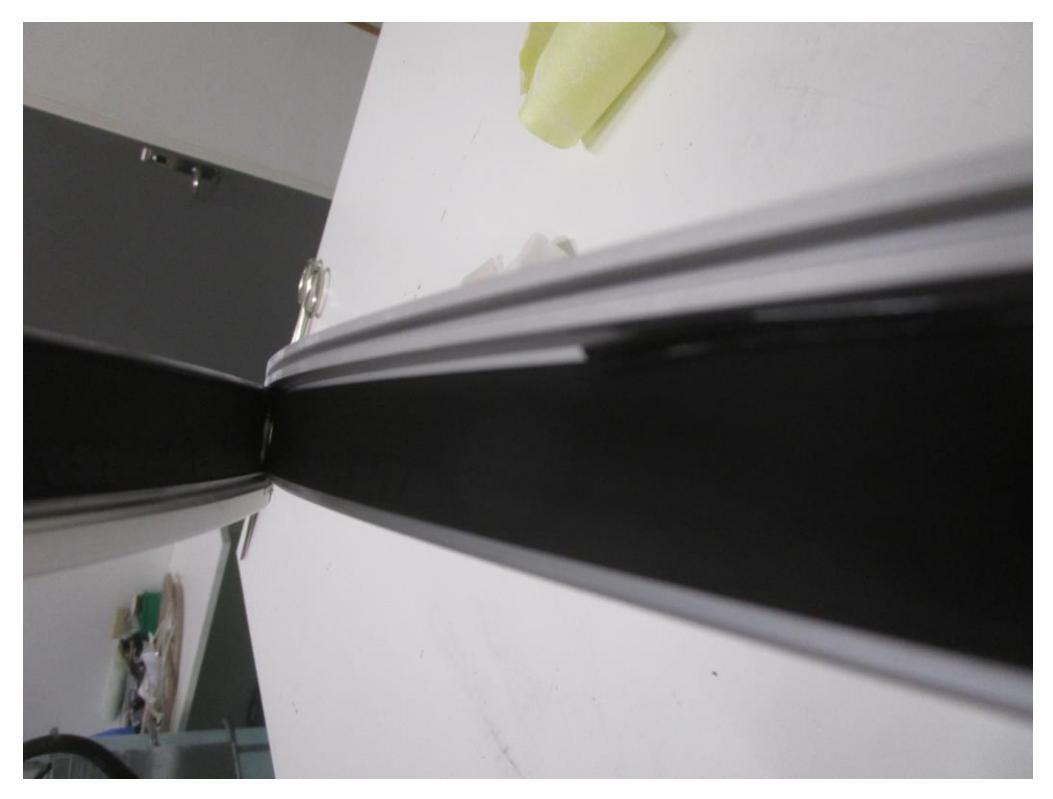
Photo 6 Visual inspection. IP6X. No dust observed inside main enclosure.

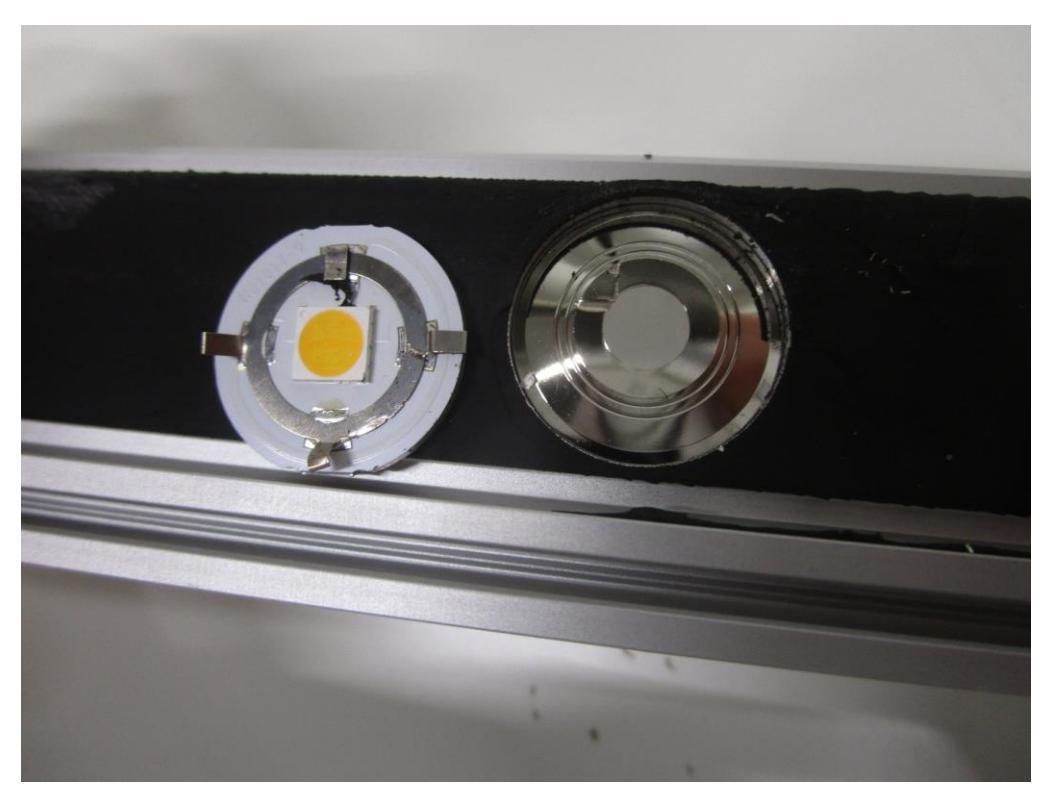
Photo 7 Visual inspection. IP6X. No dust observed inside main enclosure.

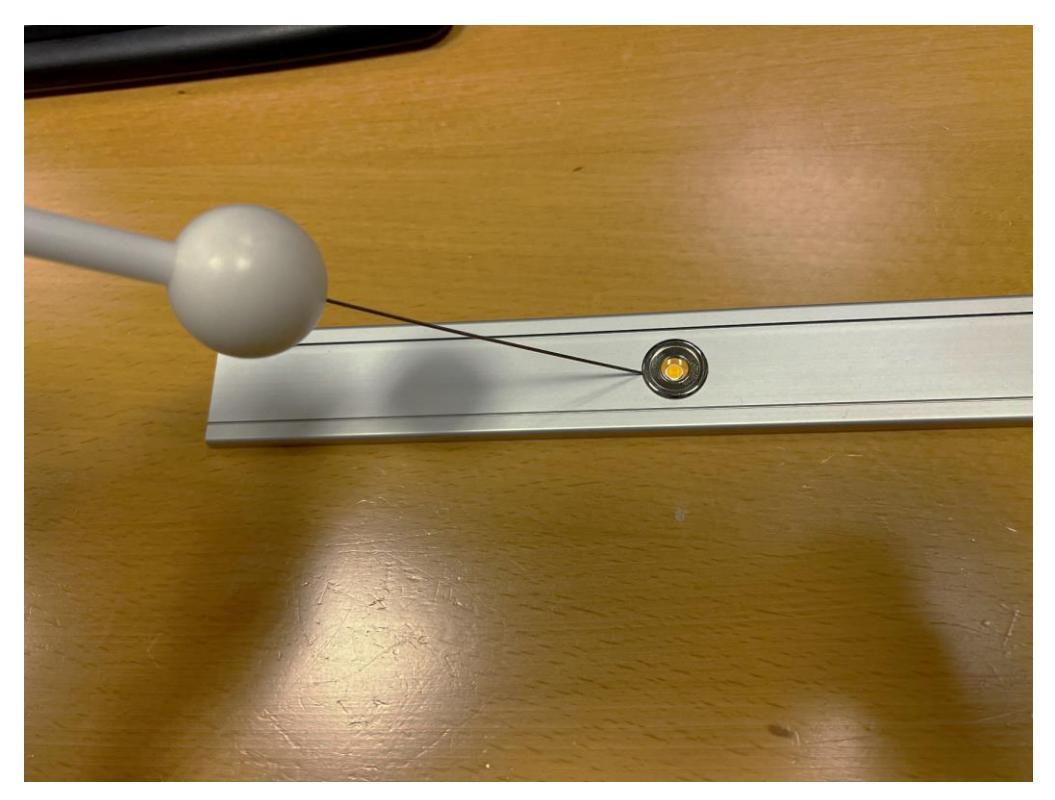
Photo 8 Enclosure protection. IP6X. 1 mm probe. Adequate clearance kept to any hazardous parts.

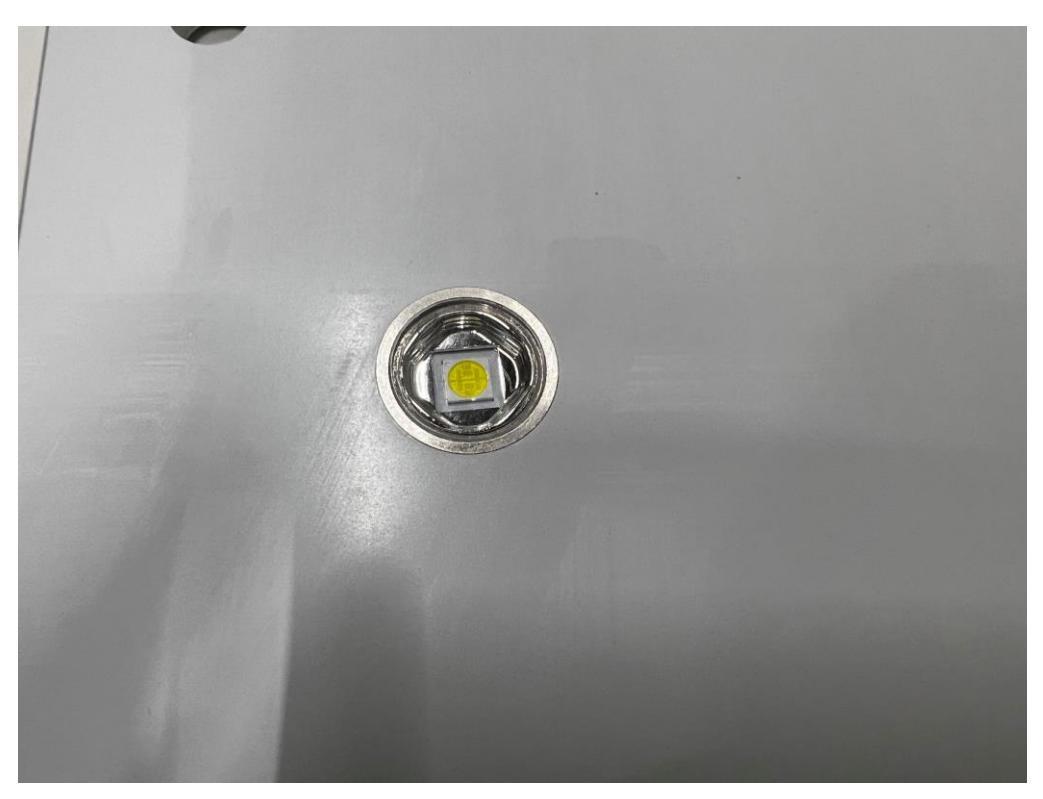
Photo 11 Visual inspection. IP6X. No dust observed inside LED sockets.

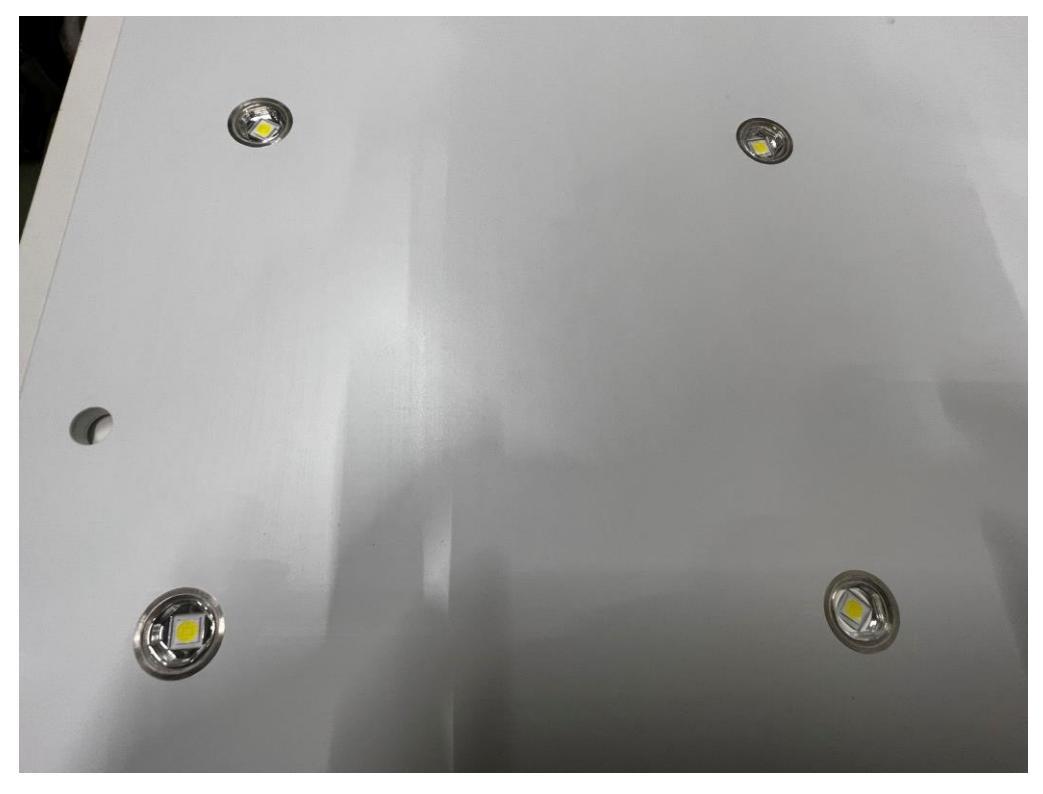
Photo 12 Visual inspection. IP6X. No dust observed inside LED sockets. Similar for all sockets.

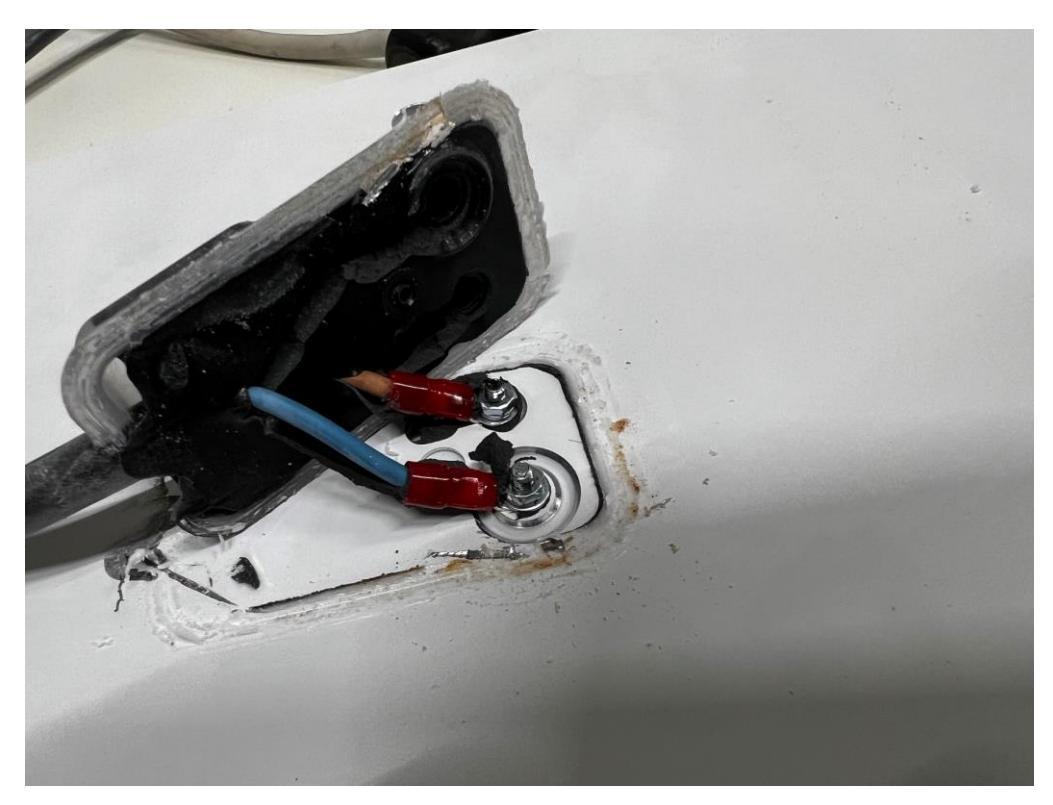
Photo 13 Visual inspection. IP6X. No dust observed inside power connection.

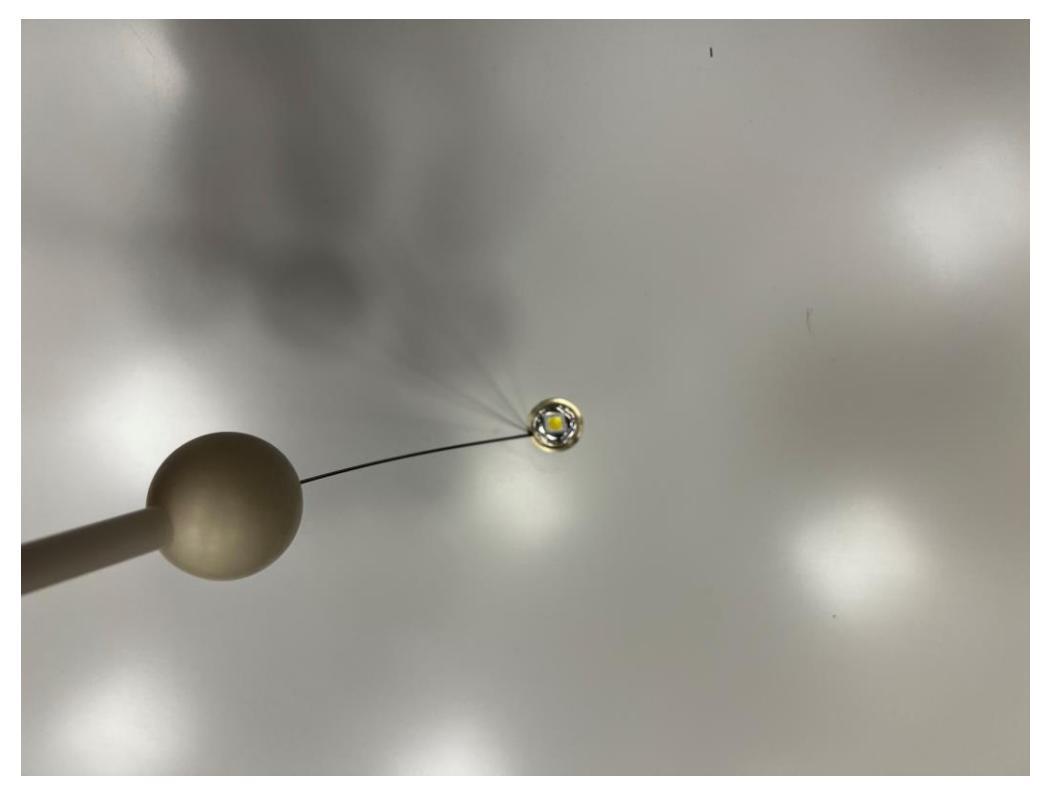
Photo 14 Enclosure protection. IP6X. 1 mm probe. Adequate clearance kept to any hazardous parts.

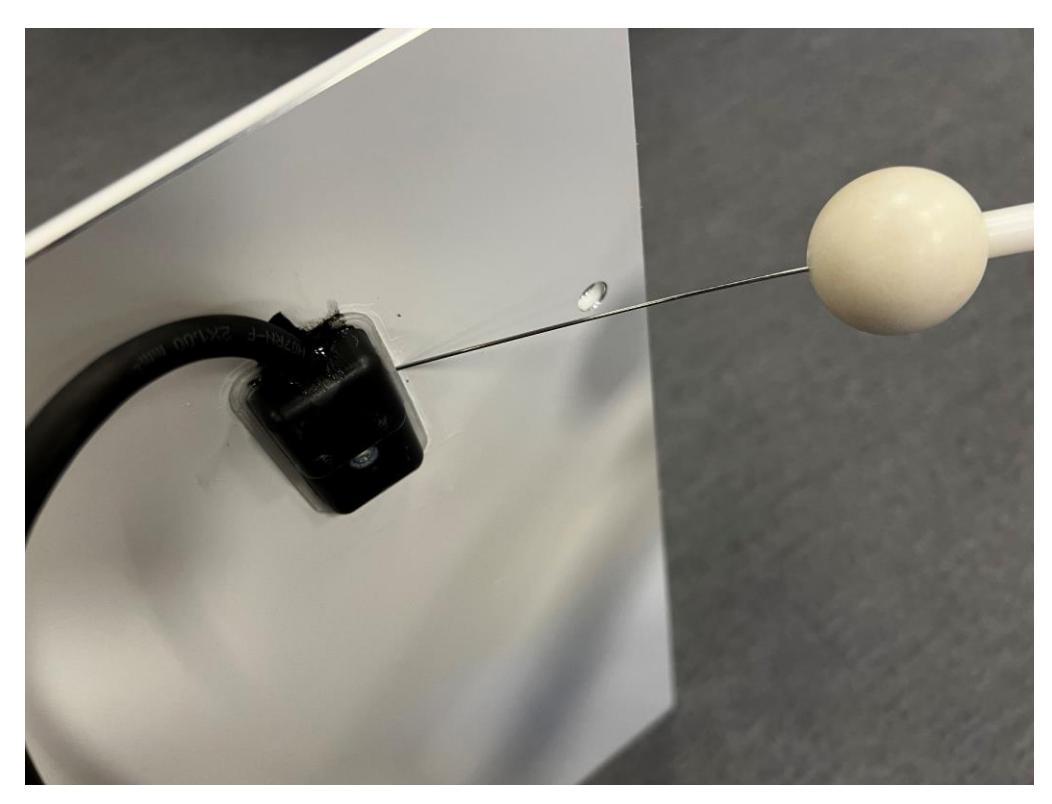
Photo 15 Enclosure protection. IP6X. 1 mm probe. Adequate clearance kept to any hazardous parts.

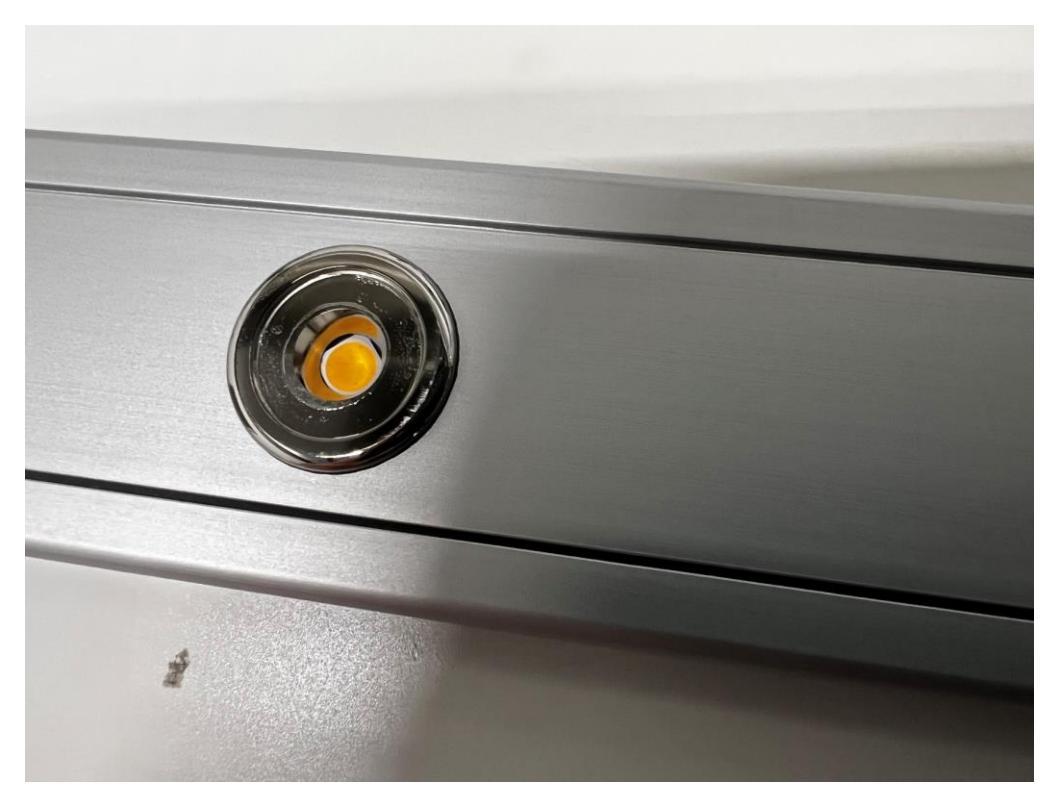
Photo 17 Visual inspection, IPX6. No ingress of water observed behind any of the LEDs.

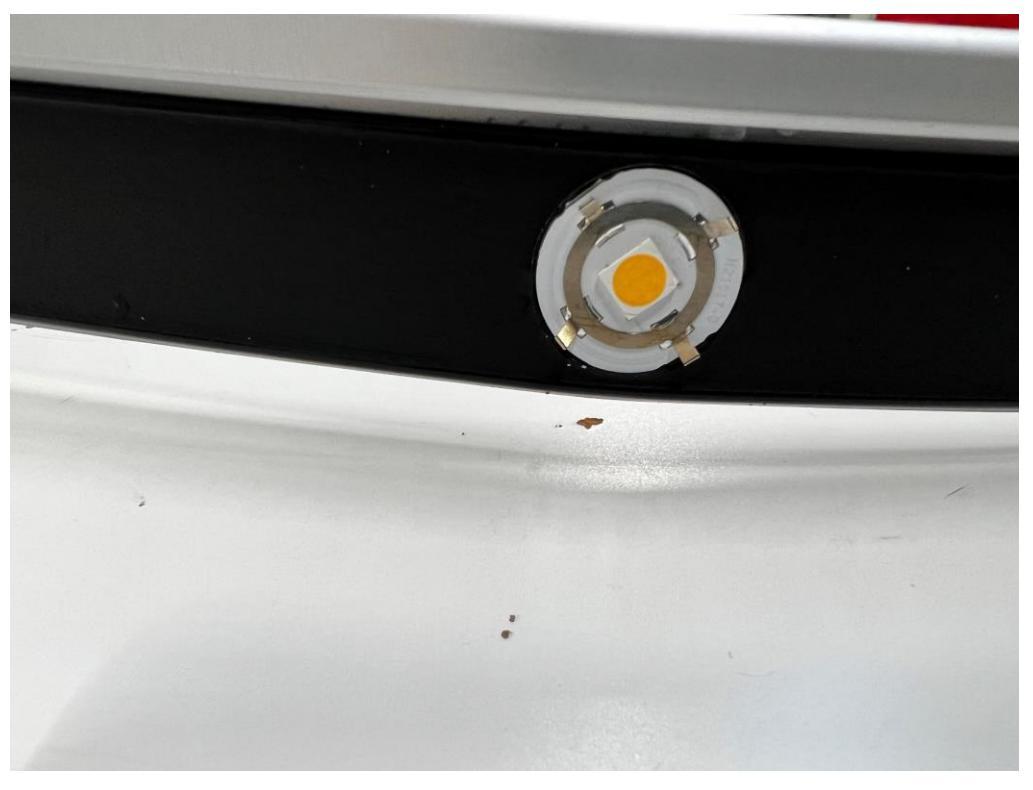
Photo 18 Visual inspection, IPX6. No ingress of water observed inside enclosure.

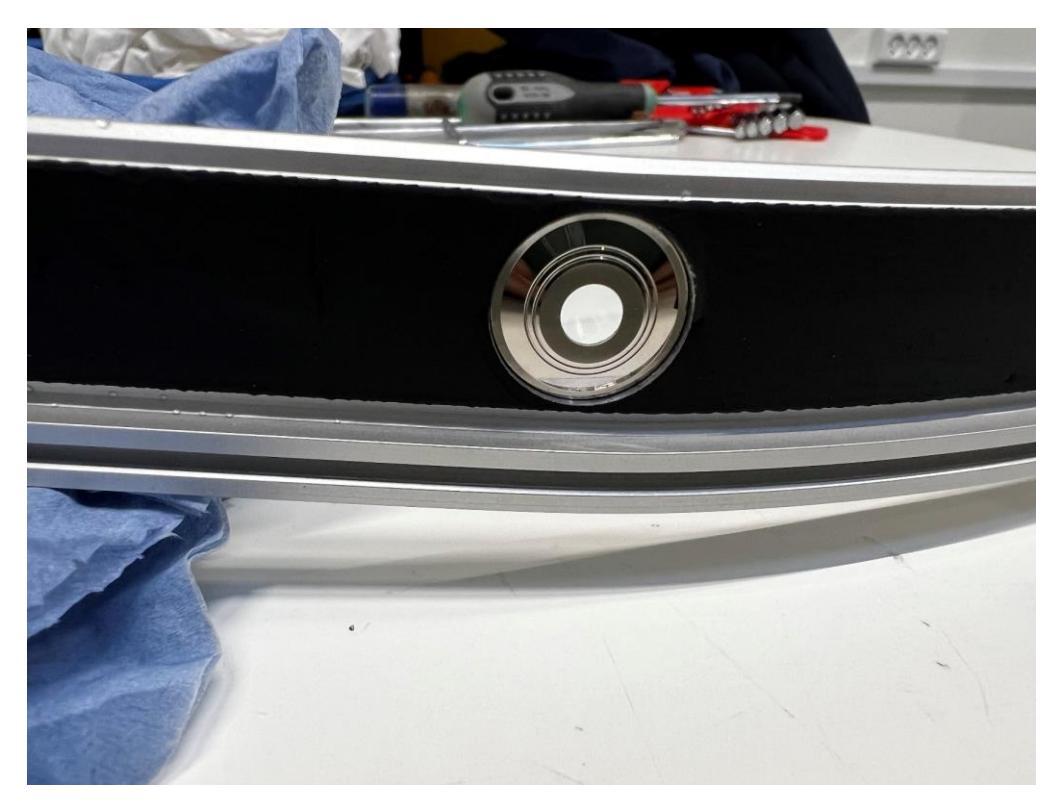
Photo 19 Visual inspection, IPX6. No ingress of water observed inside enclosure.

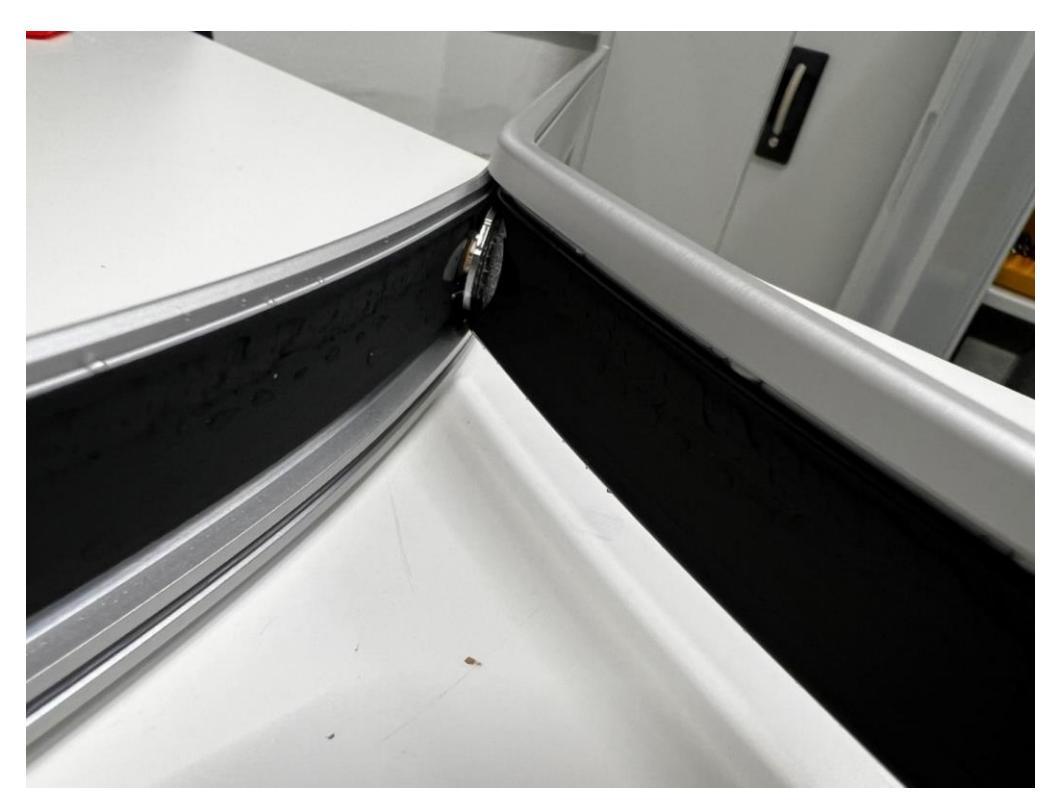
Photo 20 Visual inspection, IPX6. No ingress of water observed inside enclosure.

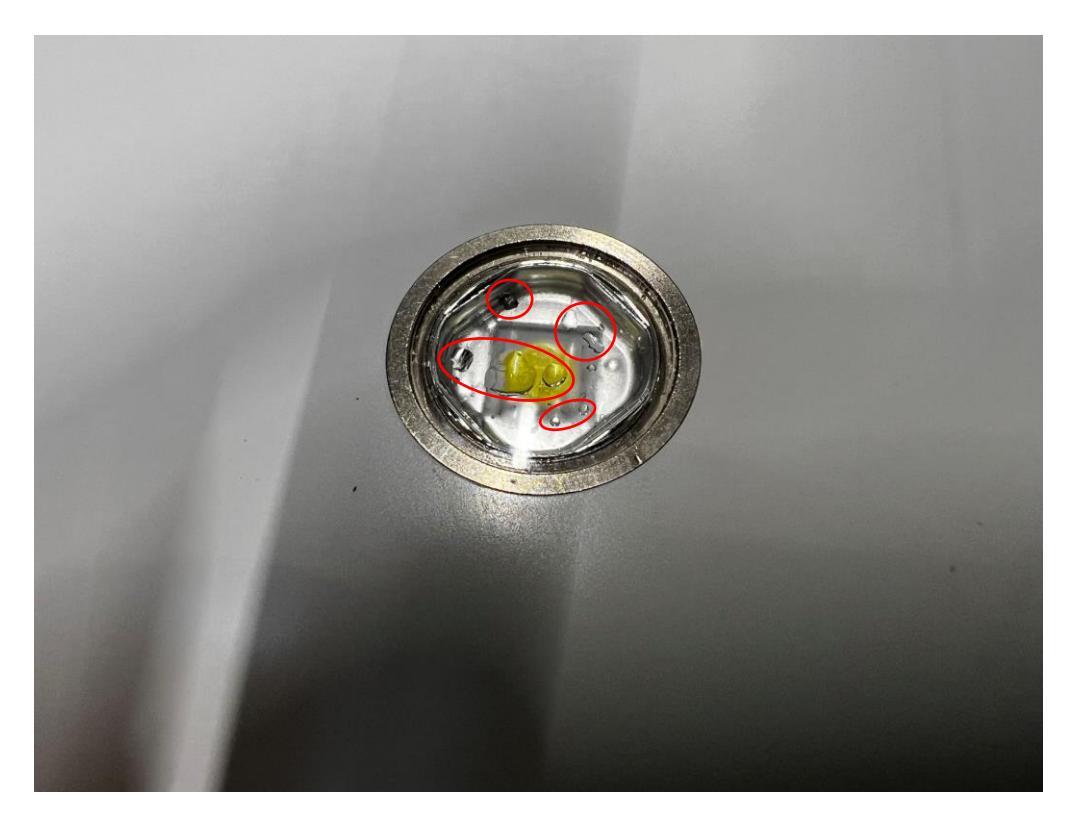
The visual inspection performed after the IPX6 test revealed water inside one of the LEDs of the Gracy LED panel. Furthermore, the LEDs were able to light up before and immediately after exposure. For detailed results, See Section 4.4.

The test was performed as specified. The visual inspection showed ingress of water inside the test object. Ingress of water was observed on the inside of one of the LEDs. The remaining 15 had no ingress of water.

Photo 22 Visual inspection, IPX6. Ingress of water observed inside one of the LEDs.

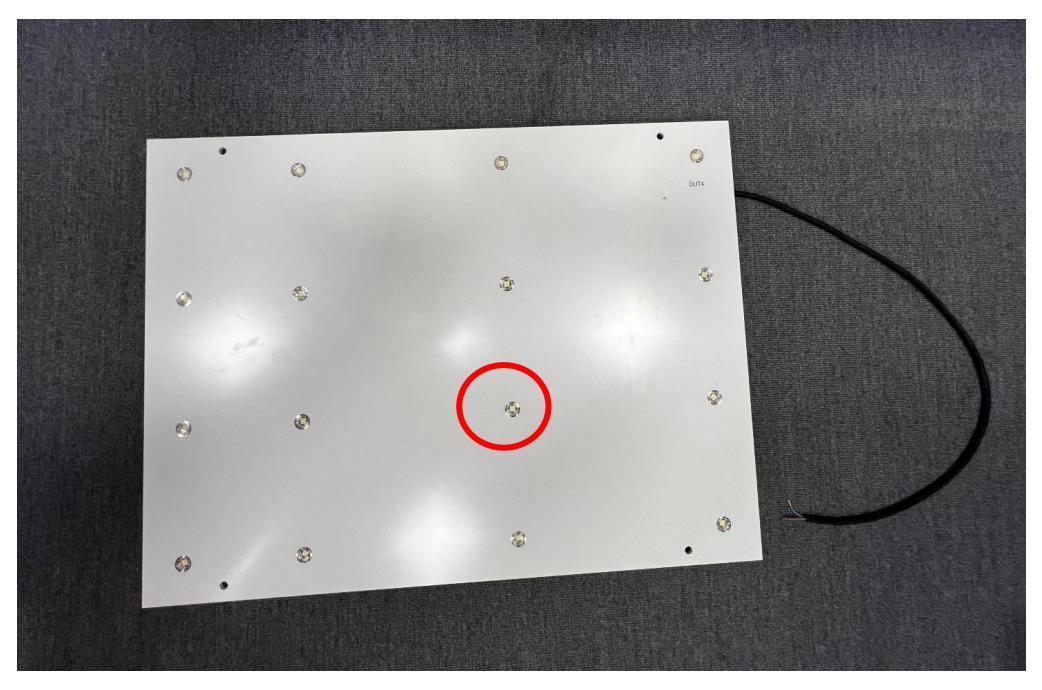
Photo 23 Visual inspection, IPX6. Ingress of water observed inside 1 LED socket, marked by red circle.

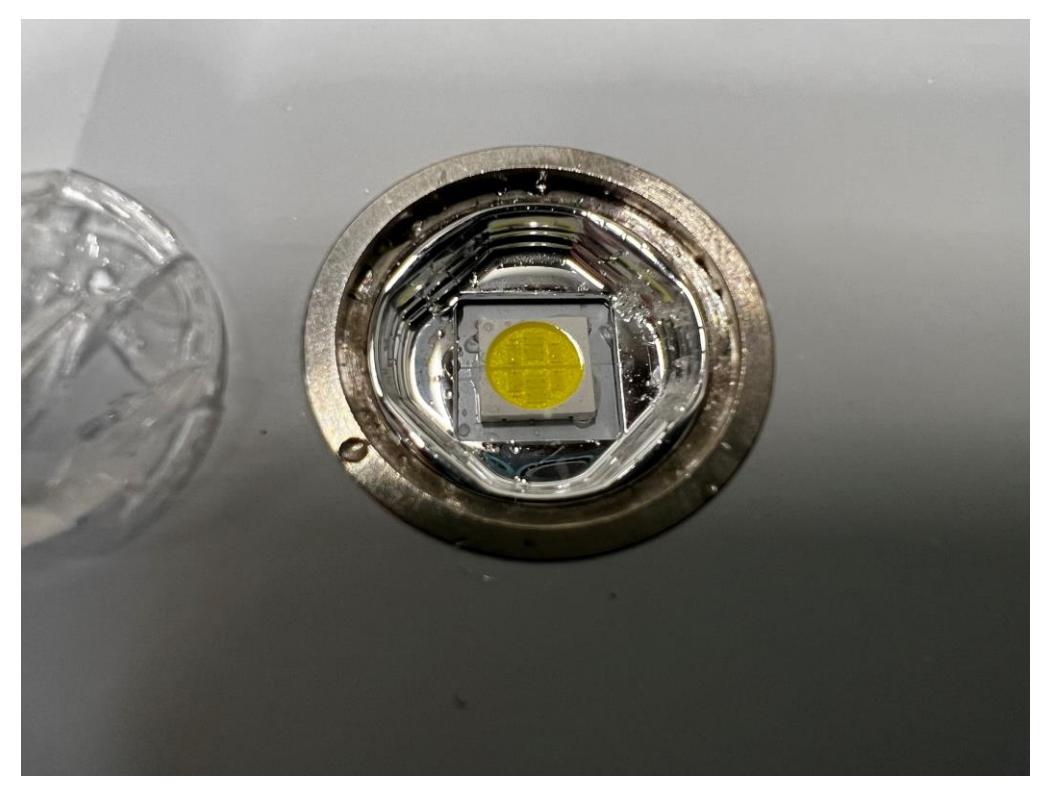
Photo 24 Visual inspection, IPX6. Ingress of water observed inside one of the LEDs

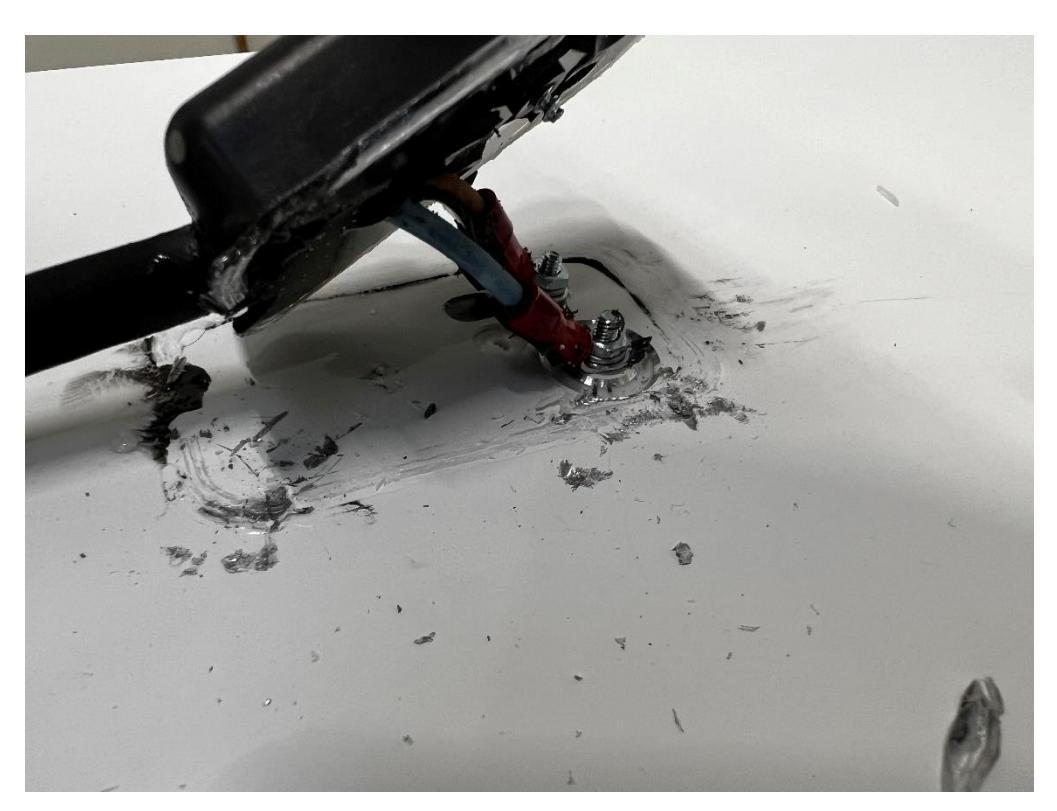
Photo 25 Visual inspection, IPX6. No ingress of water observed inside power connection.

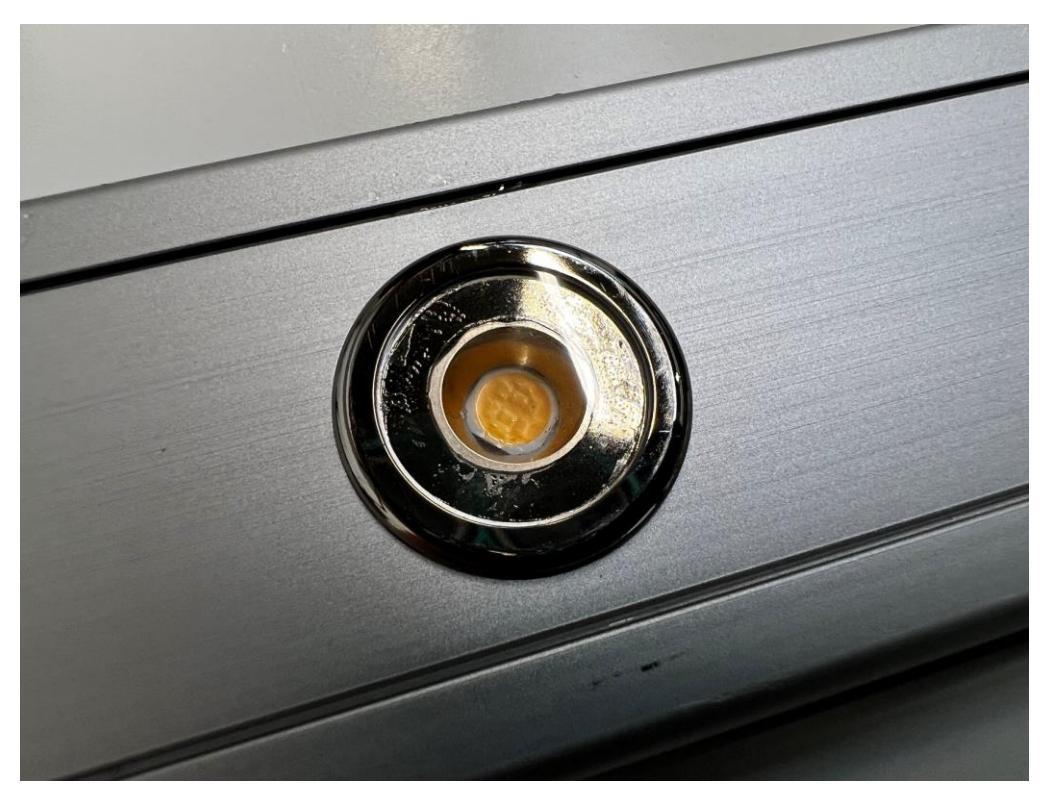
Photo 27 Visual inspection, IPX7. No ingress of water observed inside LED socket. Similar for all LED sockets.

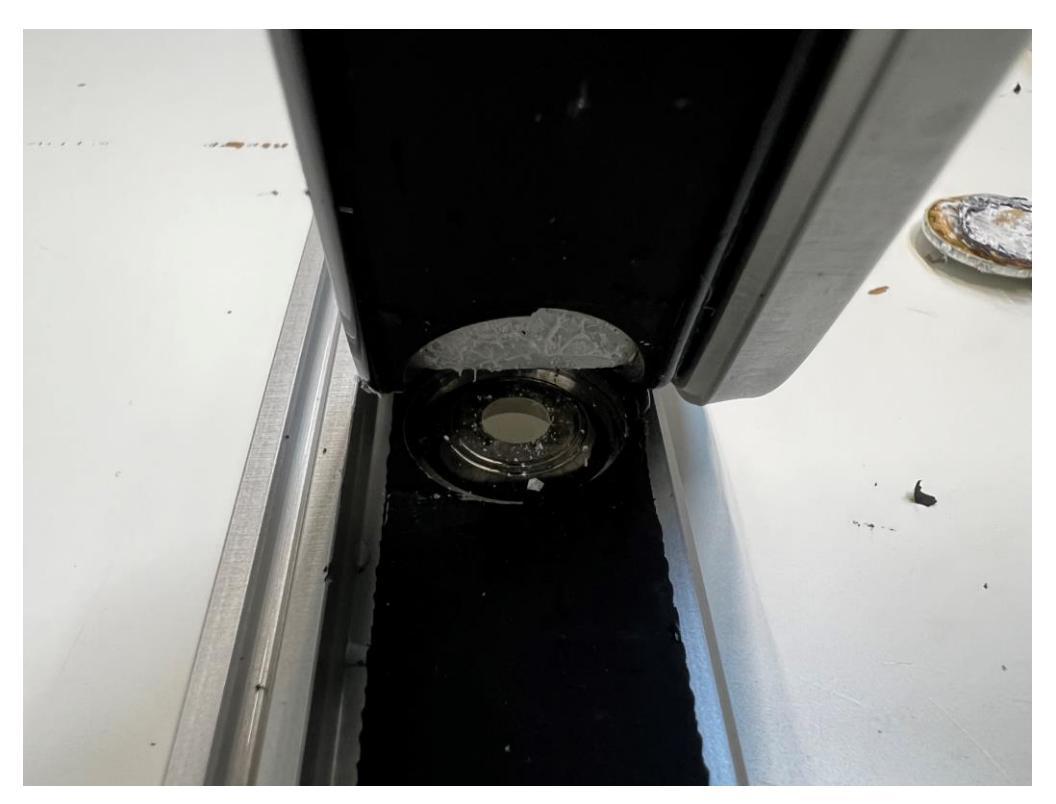
Photo 28 Visual inspection, IPX7. No ingress of water observed inside main enclosure.

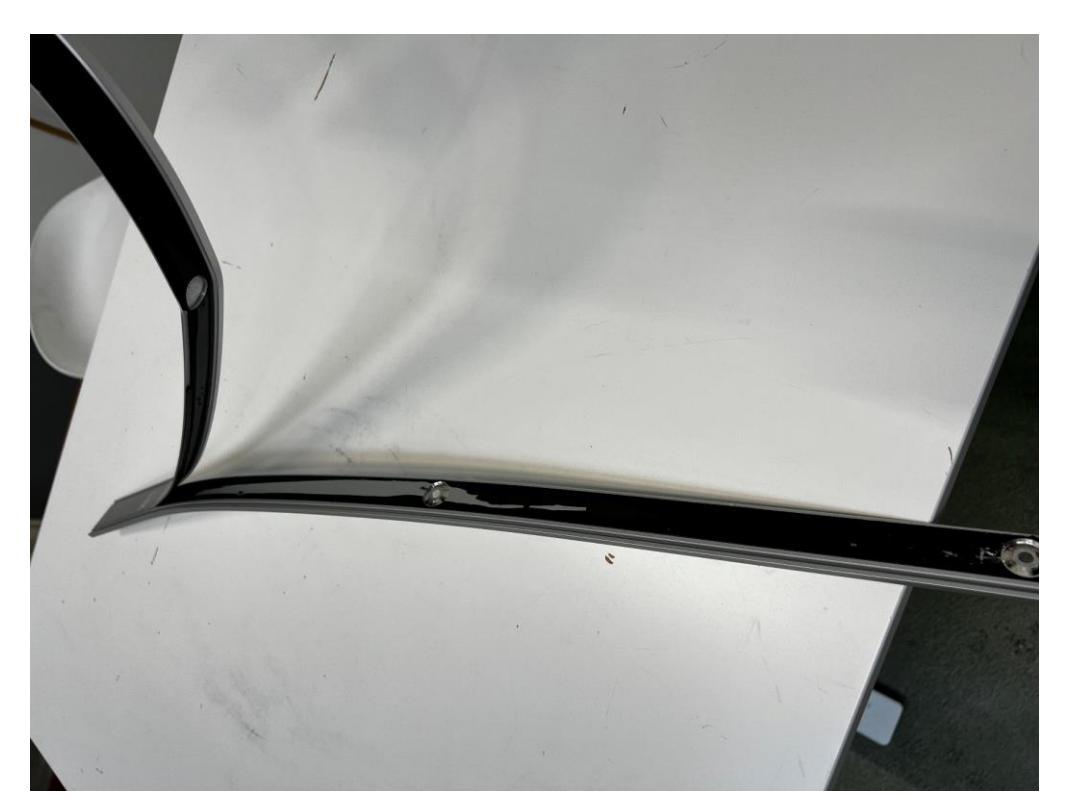
Photo 29 Visual inspection, IPX7. No ingress of water observed inside main enclosure.

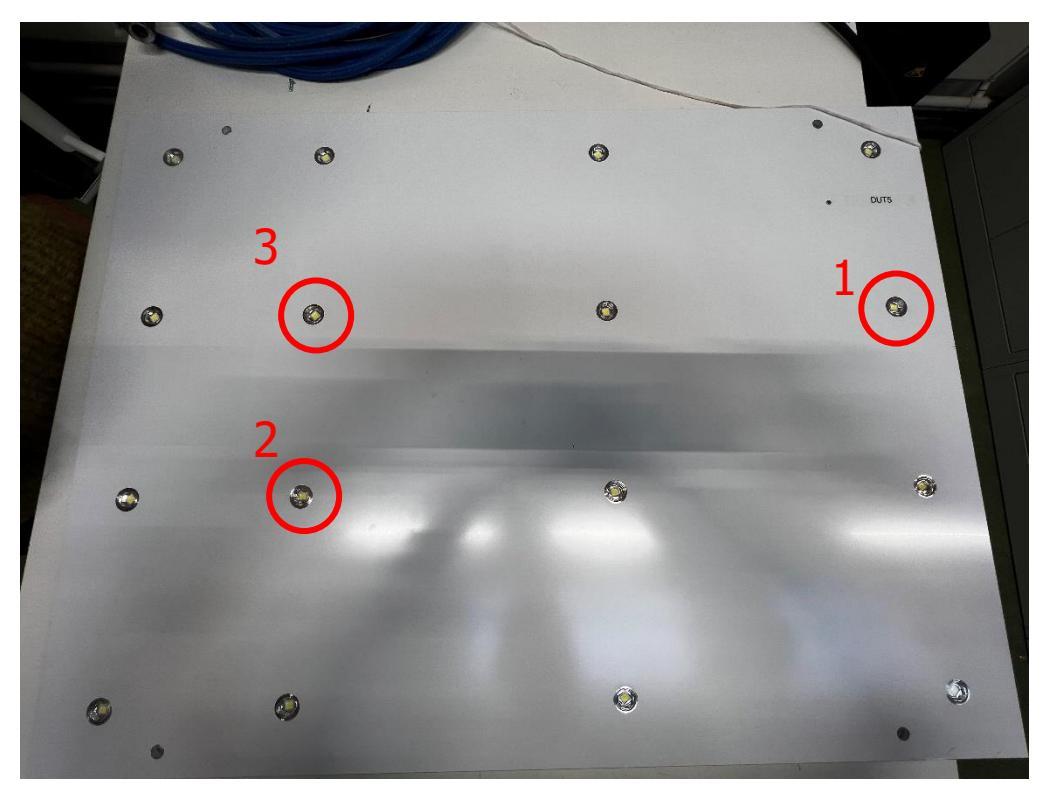
The visual inspection performed after the IPX7 test revealed water inside some of the LEDs of the Gracy LED panel. Furthermore, the LEDs were able to light up before and immediately after exposure. For detailed results, See Section 4.6.

The test was performed as specified. The visual inspection showed ingress of water inside the test object.

Photo 31 Visual inspection, IPX7. Ingress of water observed inside 3 LED sockets, marked by red circle and numbered.

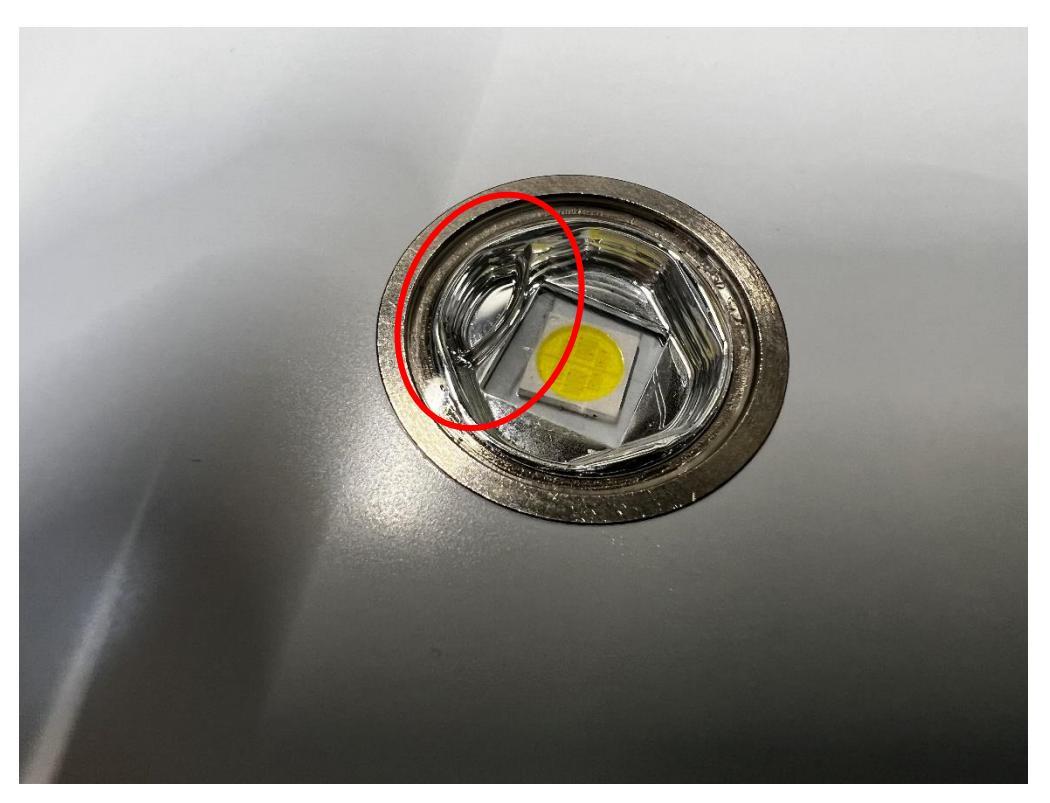
Photo 32 Visual inspection, IPX7. Ingres of water observed inside LED socket (numbered 1 on overview photo).

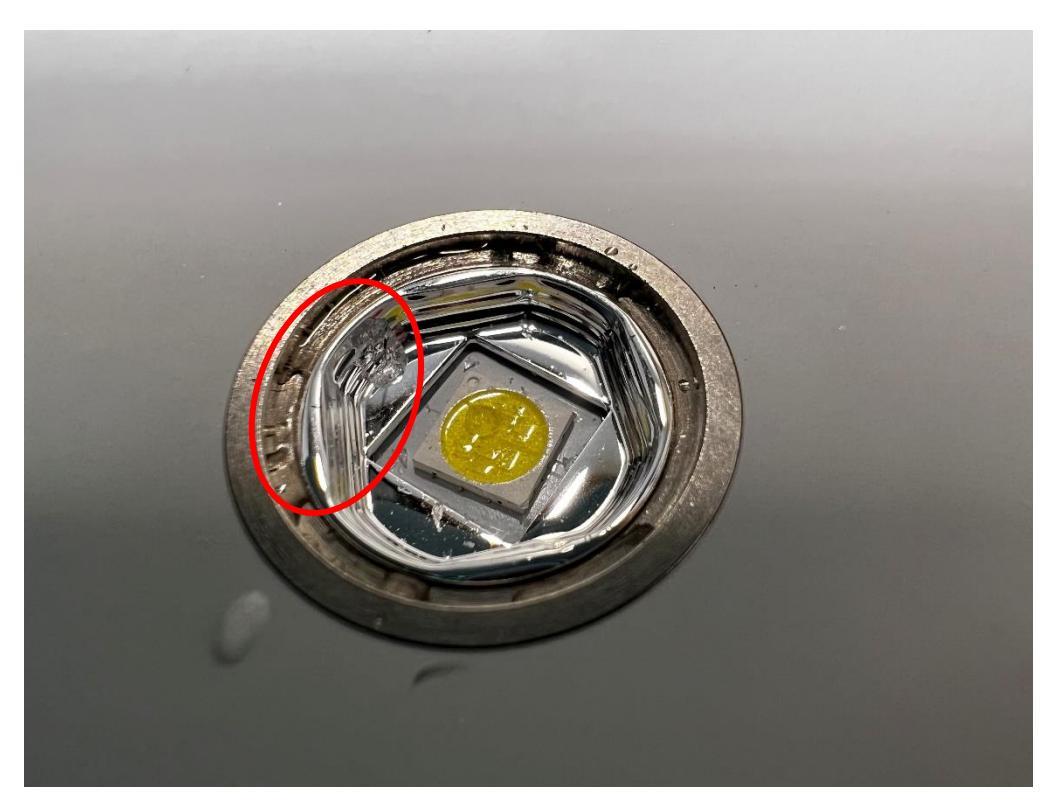
Photo 33 Visual inspection, IPX7. Ingres of water observed inside LED socket (numbered 1 on overview photo) – Lid removed. Similar when opening the sockets shown on photo 34 and 35.

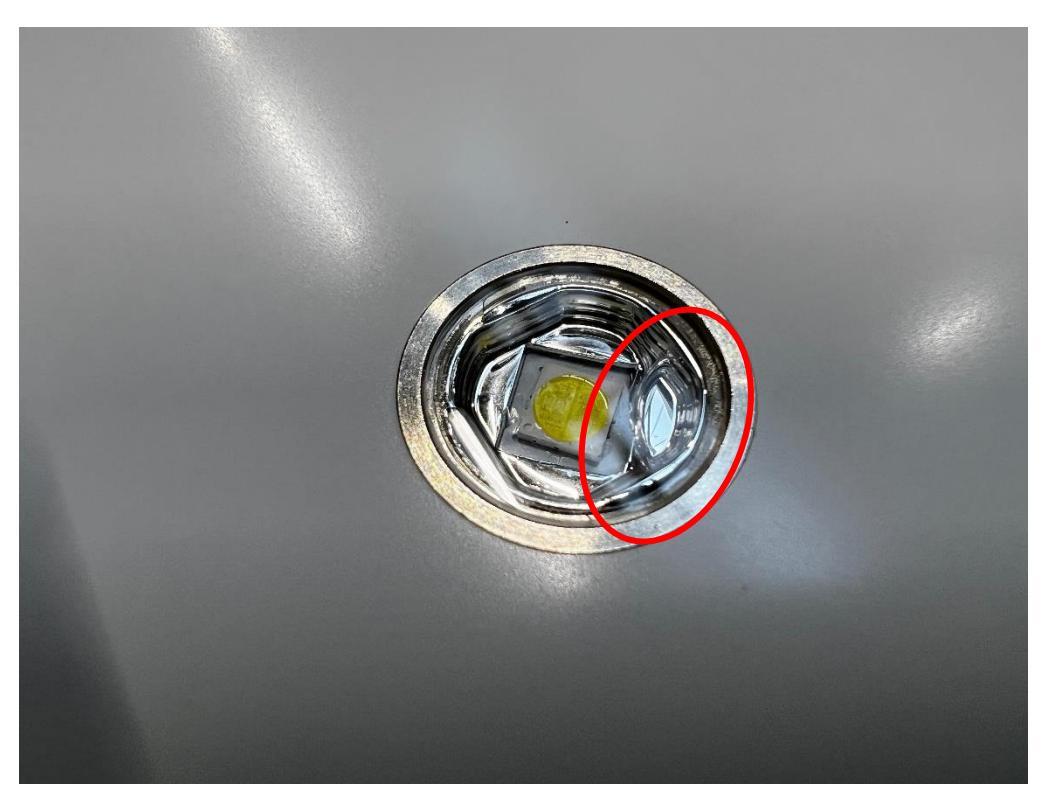
Photo 34 Visual inspection, IPX7. Ingres of water observed inside LED socket (numbered 2 on overview photo).

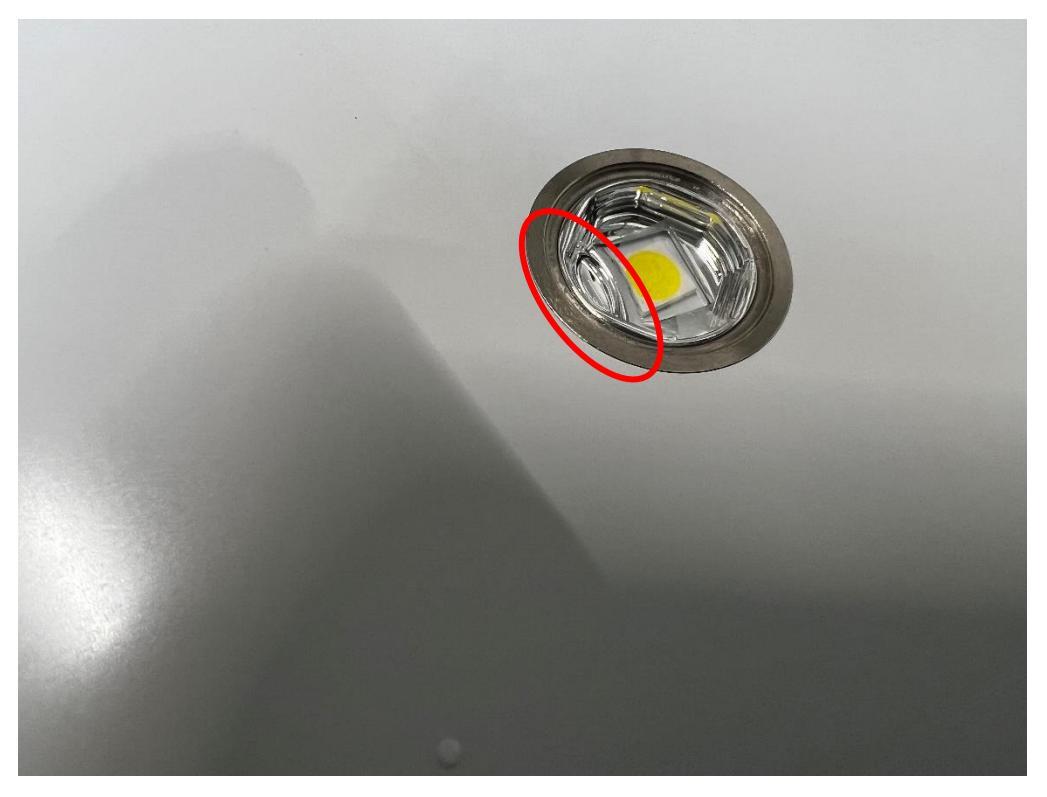
Photo 35 Visual inspection, IPX7. Ingres of water observed inside LED socket (numbered 3 on overview photo).

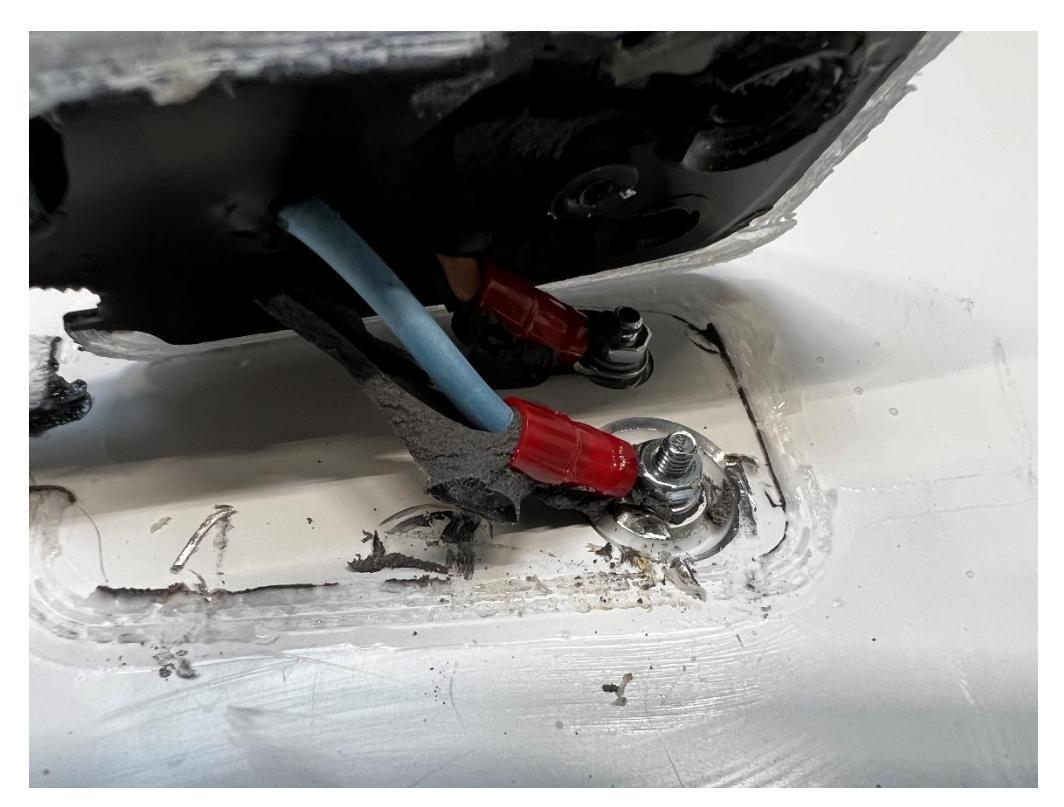
Photo 36 Visual inspection, IPX7. No Ingres of water observed inside power connection.
