TEST REPORT

IP66 and IPX7 test of Tracy and Gracy LED panel

LED iBond A/S Report no.: 122-28175-1 Page 1 of 36 1 appendix

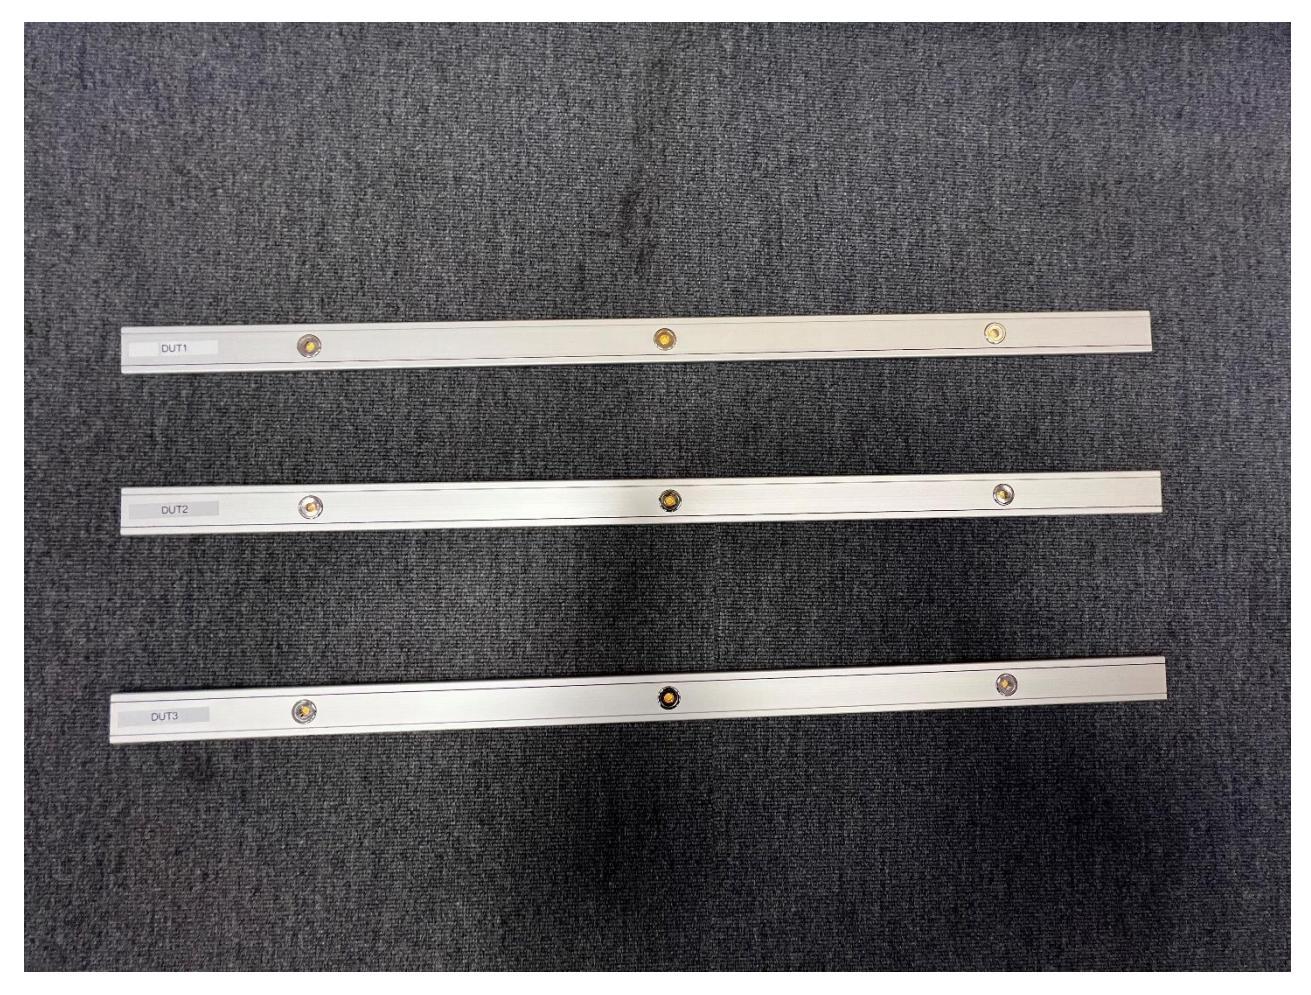
Photo 1 Test object.

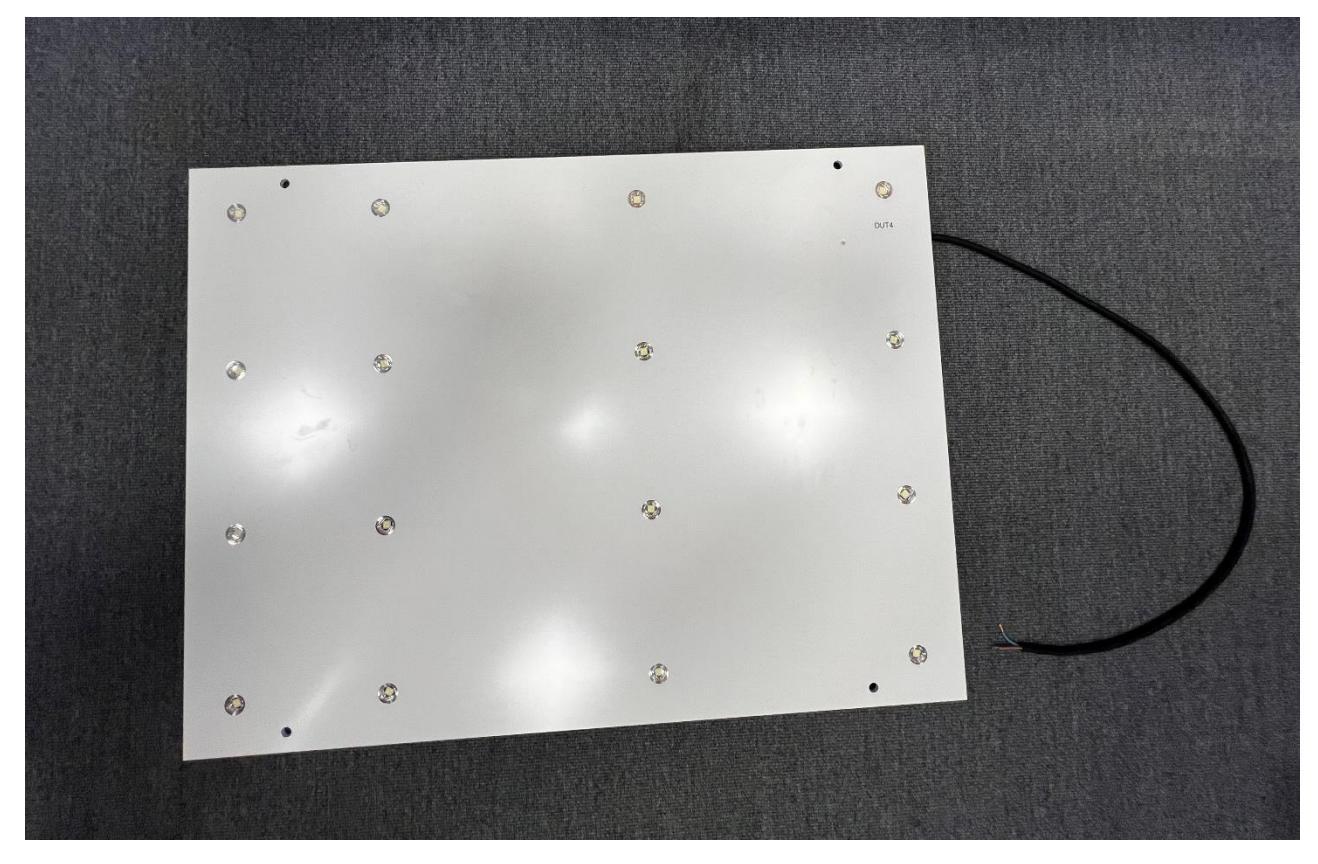
Photo 2 Test object.

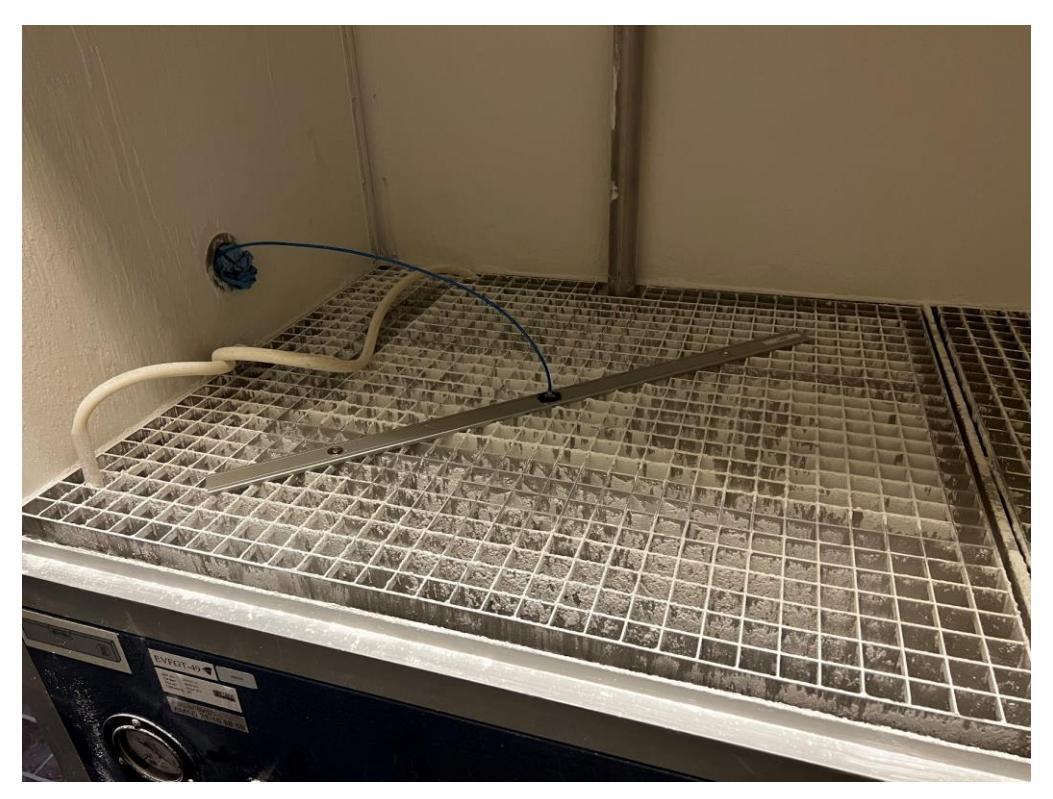
Photo 3 Before exposure, IP6X.

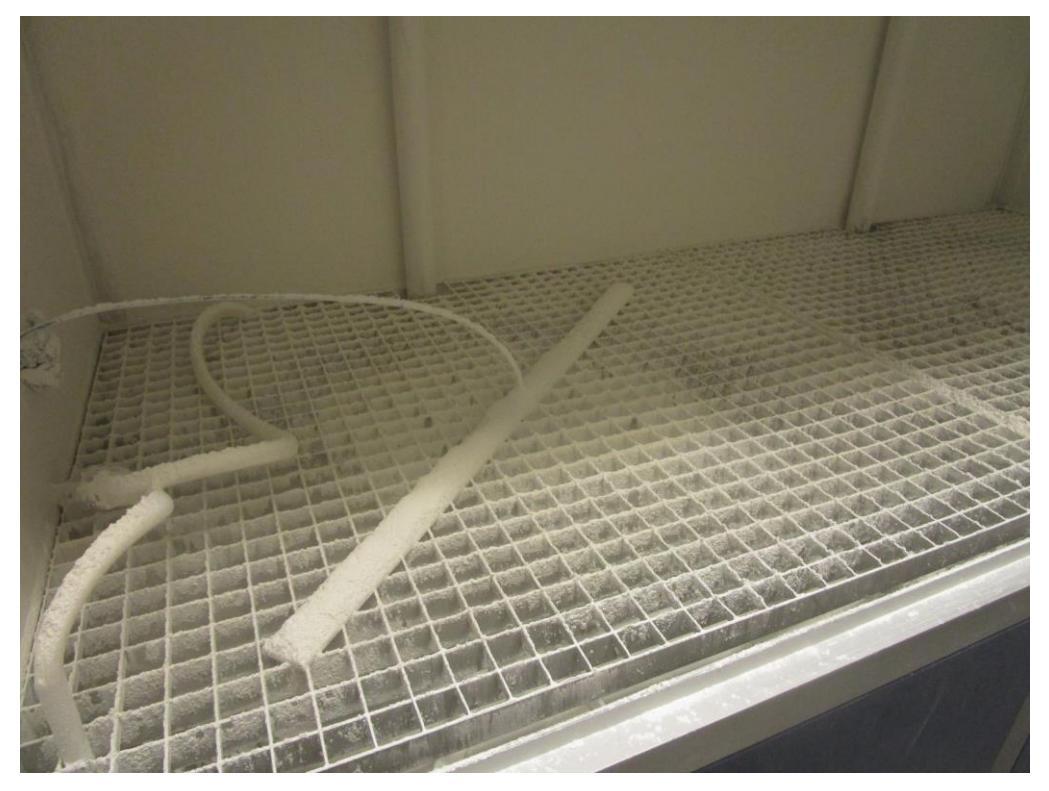
The test was performed as specified. A visual inspection showed that there was no ingress of dust inside the enclosure. Furthermore, an ø 1.0 mm test wire could not enter through any holes or openings, and adequate clearance was kept between the test wire and hazardous parts.

Photo 4 After exposure, IP6X.

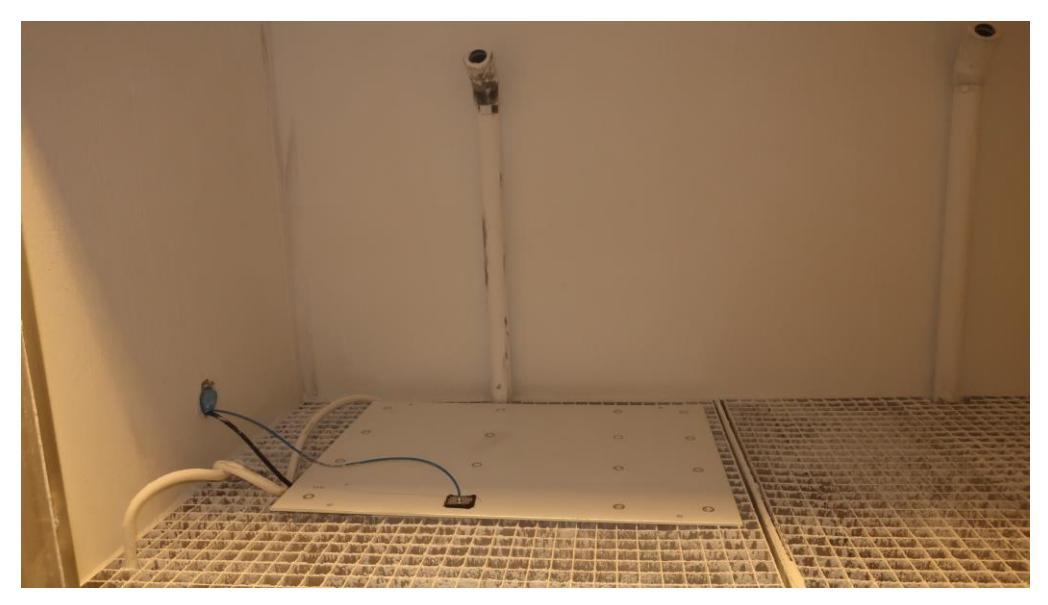
Photo 9 Before exposure, IP6X.

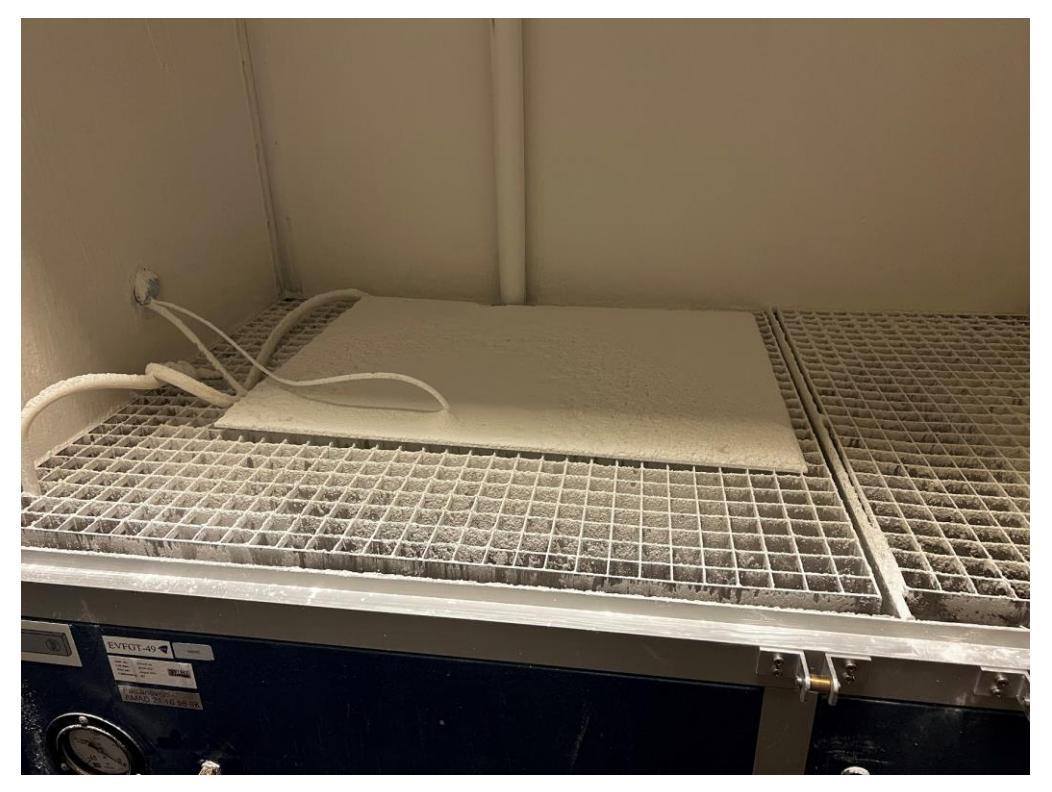
The test was performed as specified. A visual inspection showed that there was no ingress of dust inside the enclosure. Furthermore, an \emptyset 1.0 mm test wire could not enter through any holes or openings, and adequate clearance was kept between the test wire and hazardous parts.

Photo 10 After exposure, IP6X.

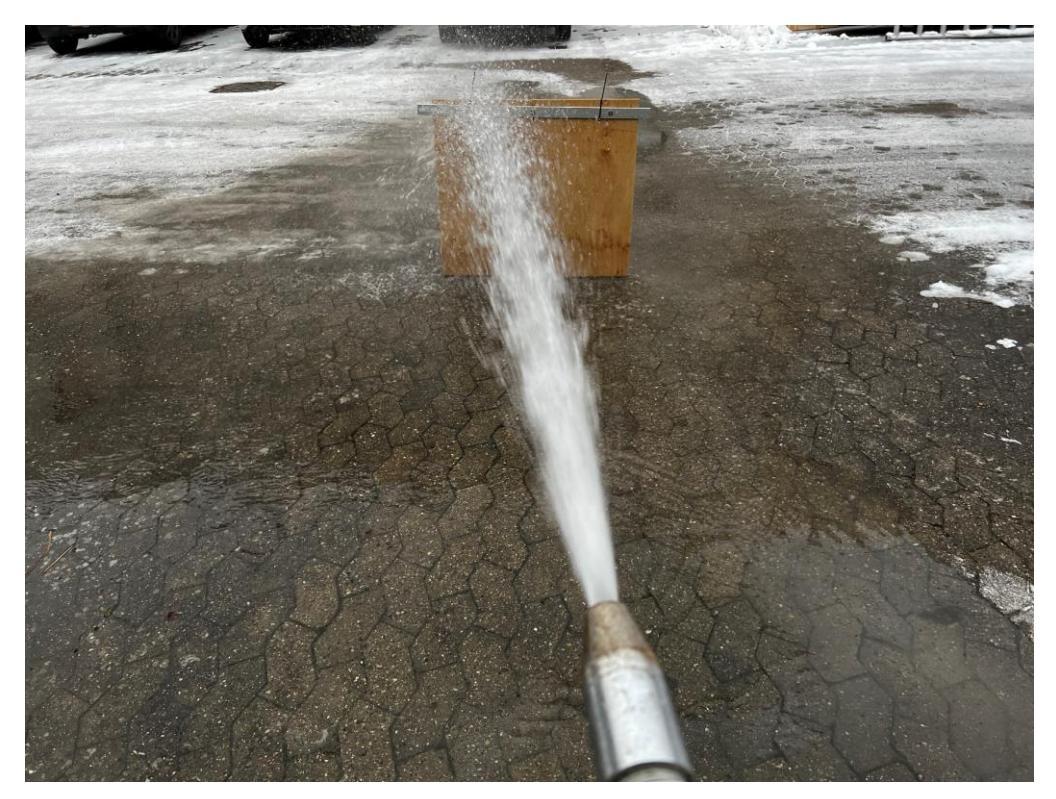
The test was performed as specified. The visual inspection showed no ingress of water inside the test object.

Photo 16 During exposure, IPX6.

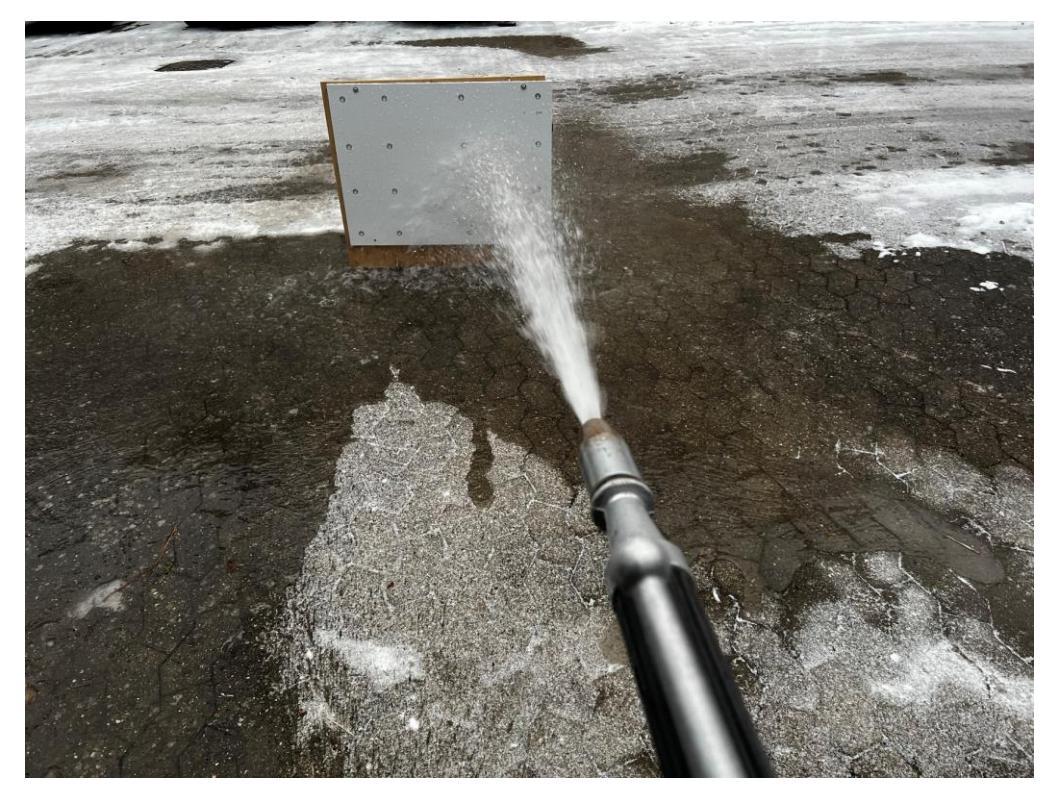
The test was performed as specified. The visual inspection showed ingress of water inside the test object. Ingress of water was observed on the inside of one of the LEDs. The remaining 15 had no ingress of water.

Photo 21 During exposure, IPX6.

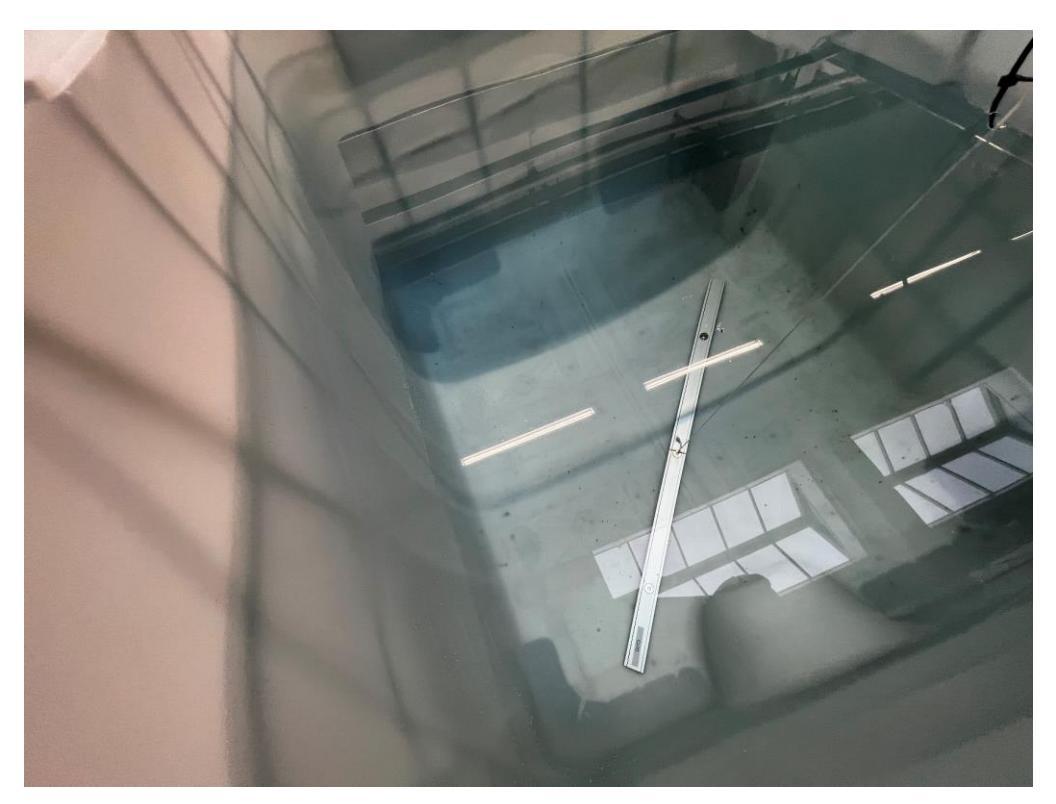
The test was performed as specified. The visual inspection showed no ingress of water inside the test object.

Photo 26 During exposure, IPX7.

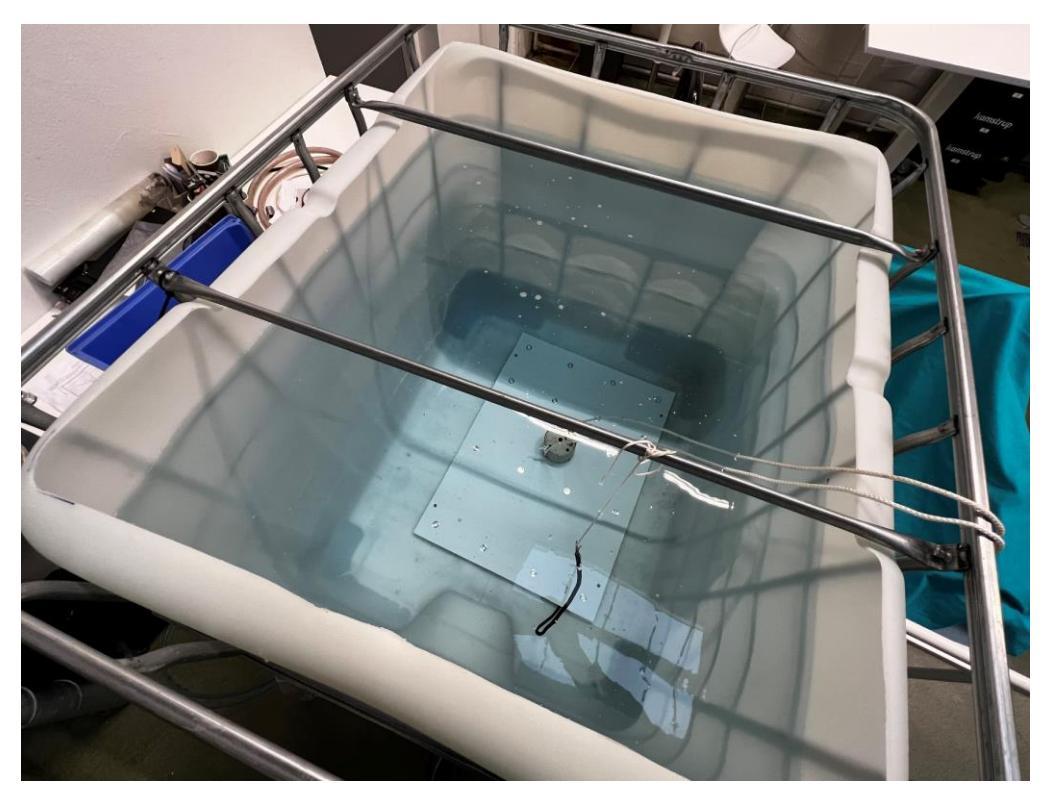
The test was performed as specified. The visual inspection showed ingress of water inside the test object.

Photo 30 During exposure, IPX7.
